# Manhole Inspection Summary

Manhole # S53M\_\_001MH

Insp Date: **4/3/08 12:16 PM**

**Location** Address: **rear of 1018 Dillon ODonnell** Cross Street: **Cliton Highland**

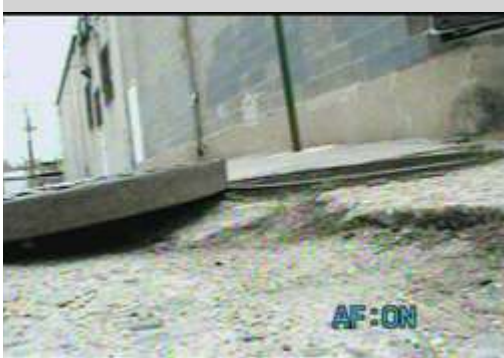
misc

above grade

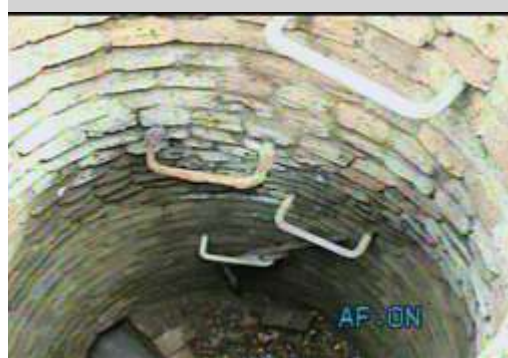
Defect 1

**Steps** Count: **4** Missing: **0** ☒ **Corroded**

corroded stairs

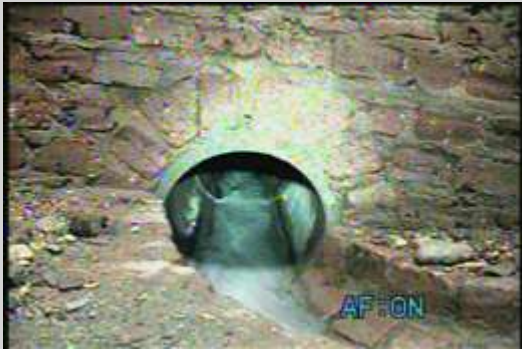
12 O'Clock Outflow

10 in. Circular Gravity Sewer  
Pipe Out @ 12 O'Clock

Invert Depth: **8.06** (ft.) Flow Characteristics: **Fast**

Infiltration: **None** Pipe Seal Cond: **Unknown**

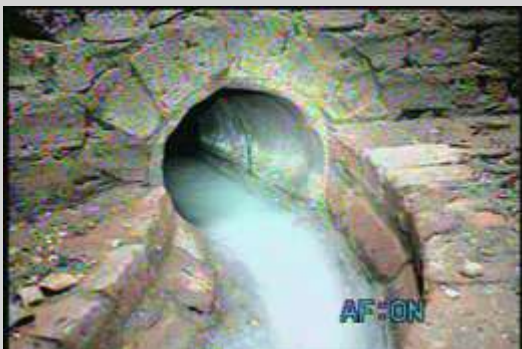
3 O'Clock Inflow

10 in. Circular Gravity Sewer  
Pipe In @ 3 O'Clock

Invert Depth: **7.86** (ft.) Flow Characteristics: **Fast**

Infiltration: **None** Pipe Seal Cond: **Unknown**
